## Sound Pressure Level Test Report

Report No. : PH1\_08\_0284

**Category: NAS**  
**Model Name: M3800**

### Thecus Tech., Corp.

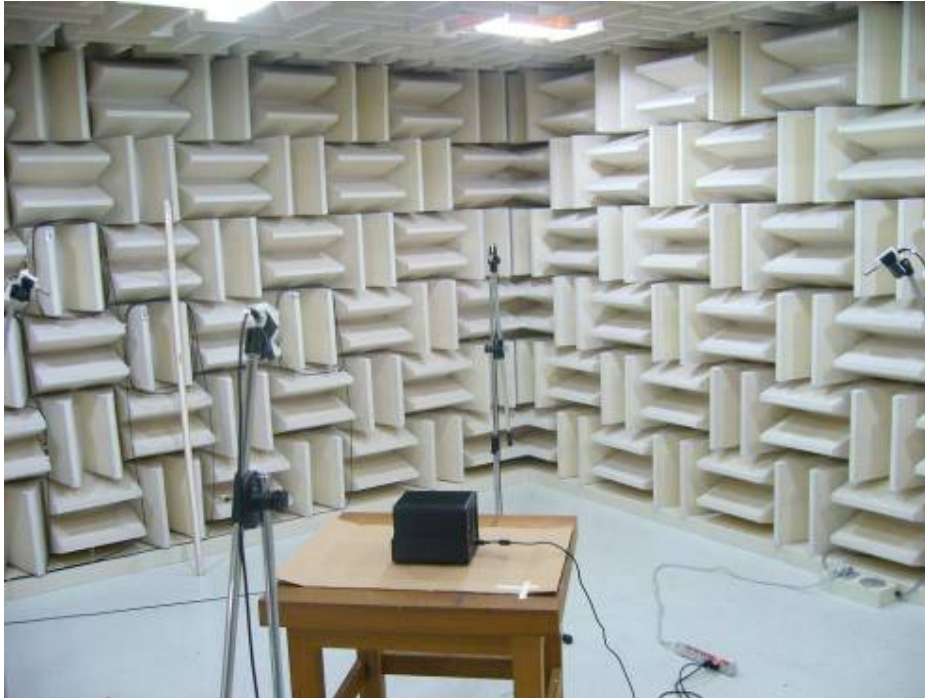
Fig. 3 Setup photo (overall view)

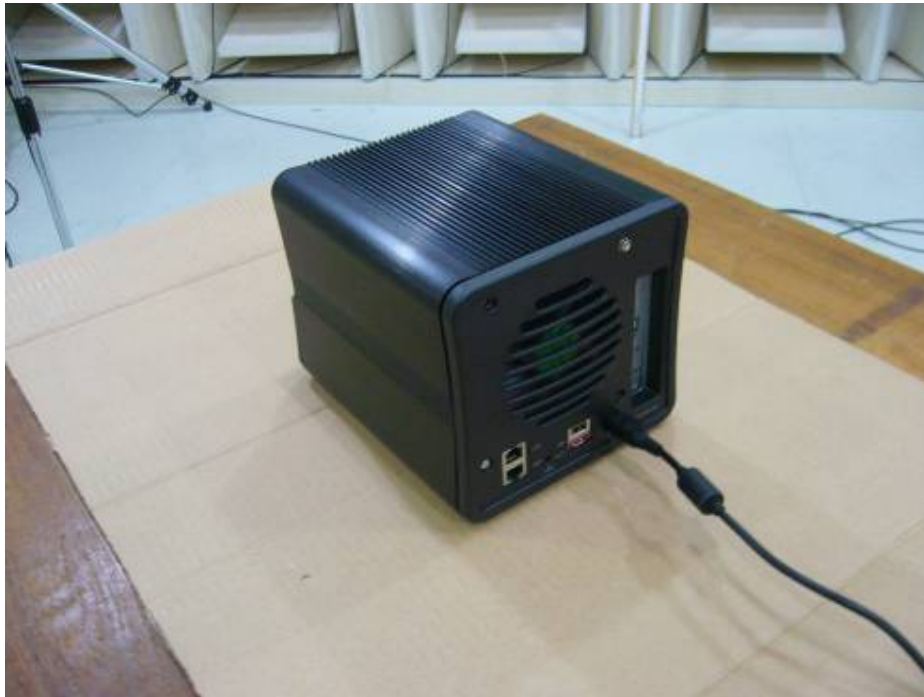
Fig. 4 Setup photo (close view)
