## Sound Pressure Level Test Report

Report No. : PH1\_08\_0284

**Category: NAS**  
**Model Name: N8800**

### Thecus Tech., Corp.

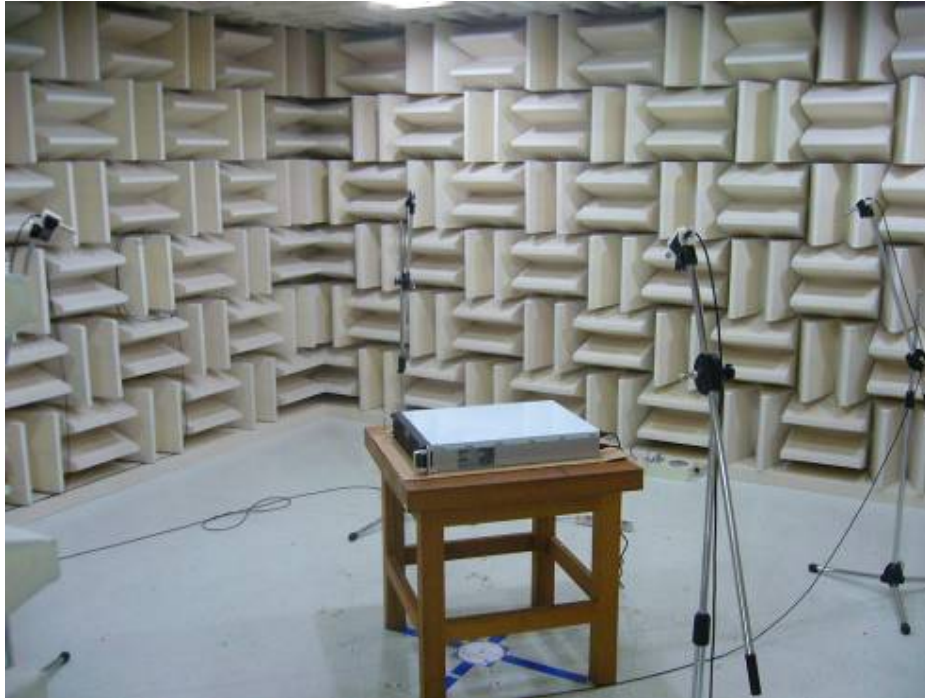
Fig. 3 Setup photo (overall view)

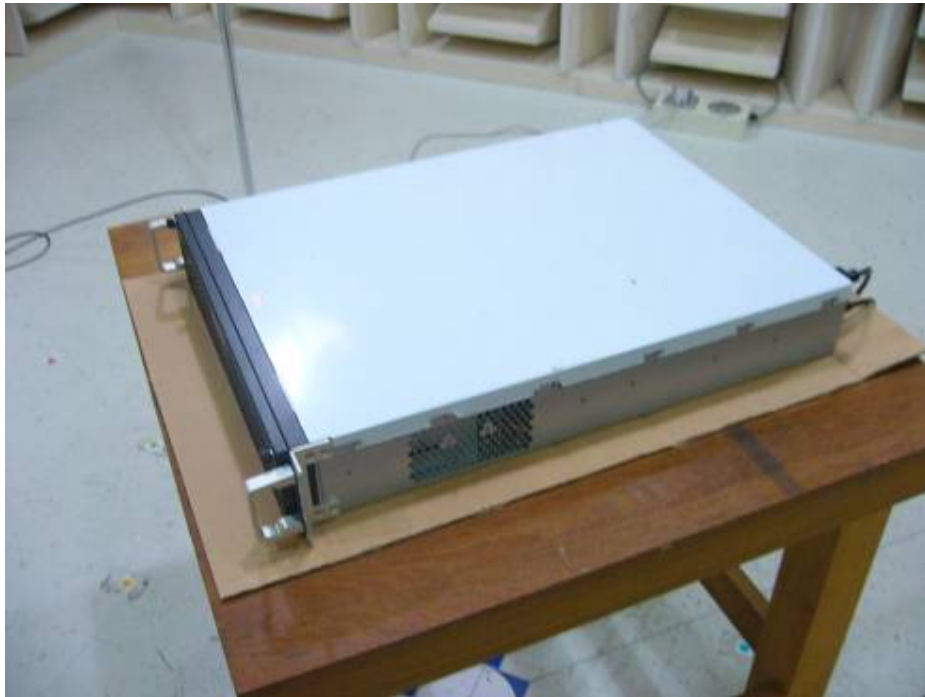
Fig. 4 Setup photo (close view)

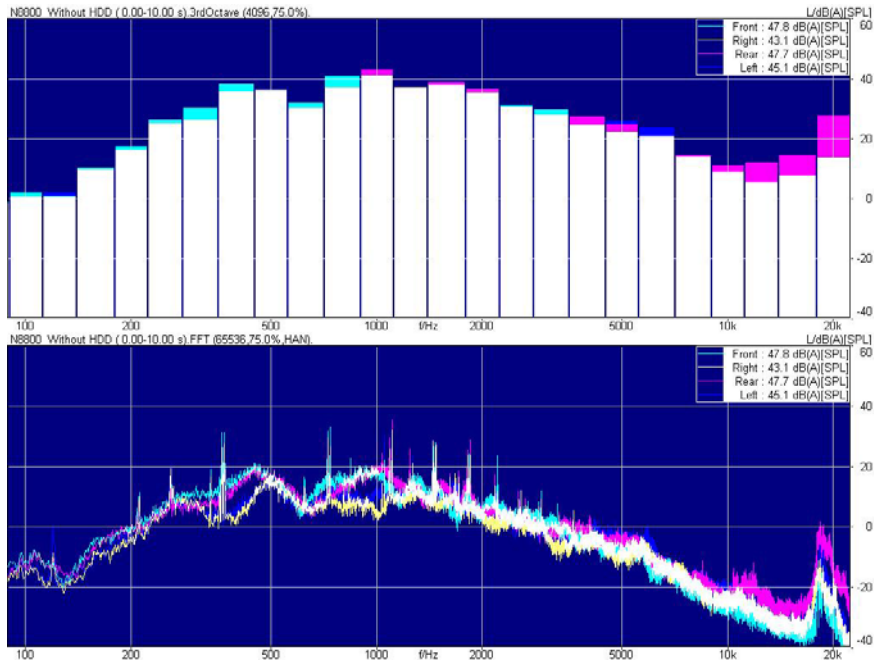
Fig. 6 N8800\_Without HDD

**Frequency Bandwidth:** The testing frequency bandwidth is 100Hz~20KHz in 1/3 Octave bands

**Frequency Weighting:** The testing frequency weighting is A-Weighted
